95% SUBMISSION

RESTORATION DRAWINGS —
SANDSTONE AND BRICK
REPAIR

VAMC
RENOVATE
BUILDING 33

A3.6

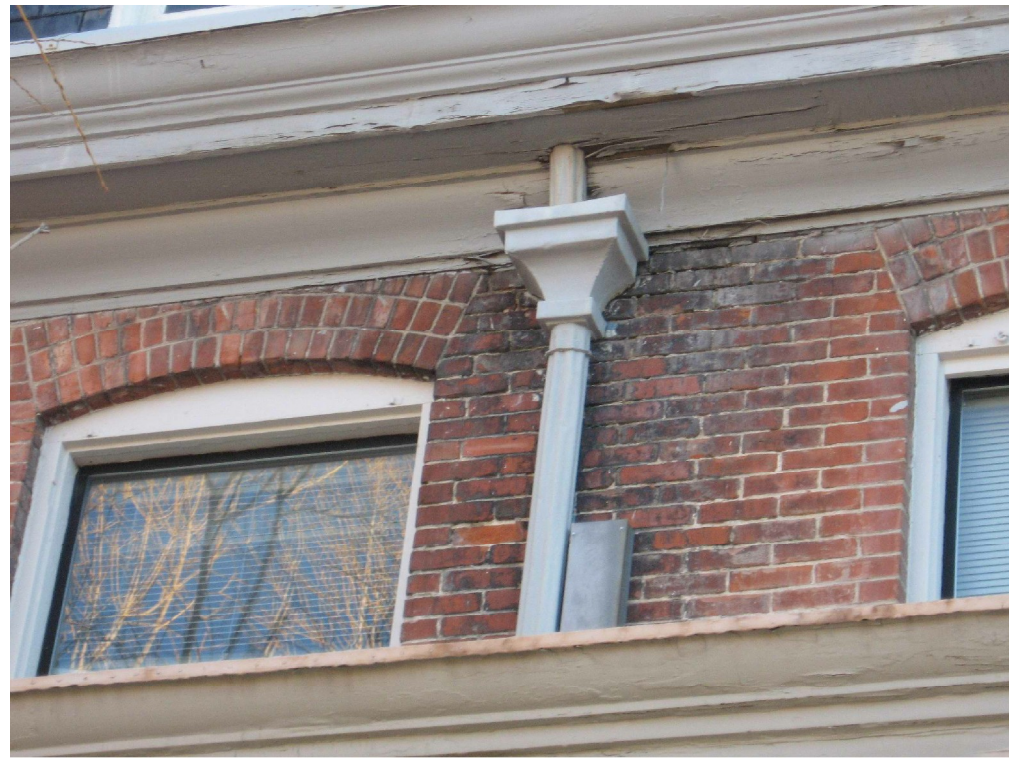
1 BROKEN BRICK

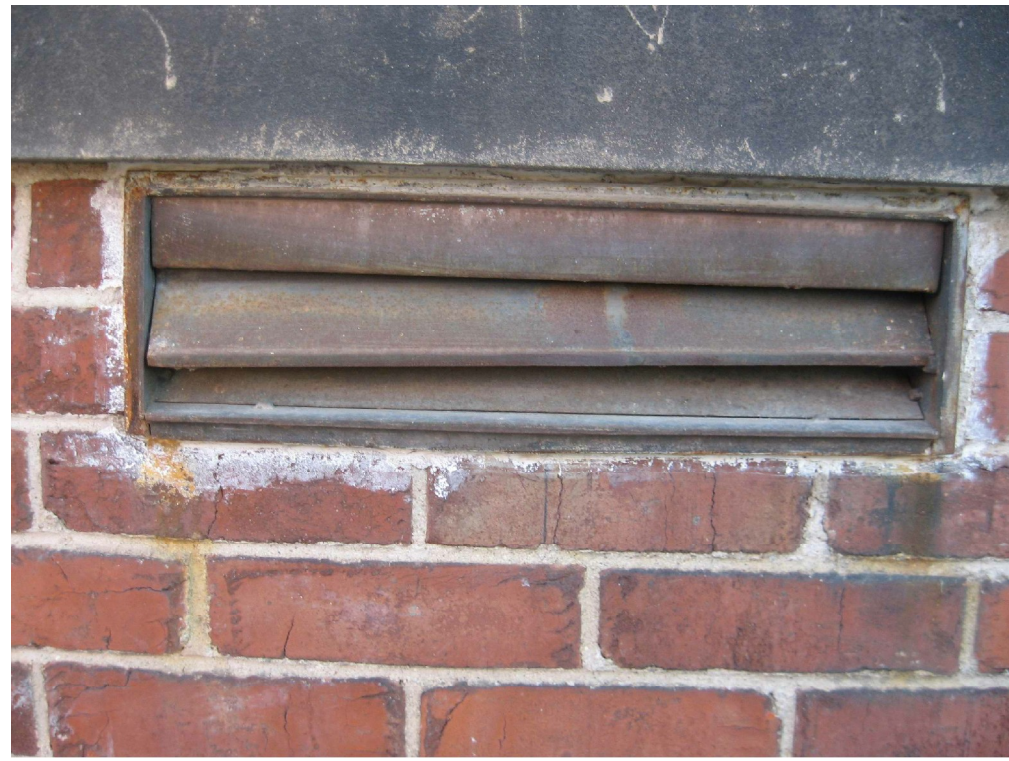
2 BROKEN VENT IN BRICK

- C. REPLACE GROUT AROUND UNDER WINDOW VENTS.
- D. PROVIDE NEW SEALANT UNDER WOOD WINDOW SILLS AND SANDSTONE, AND AROUND WOOD FRAMES AT BRICK.
- E. SEAL BETWEEN WOOD INTEGRATED GUTTER AND BRICK.

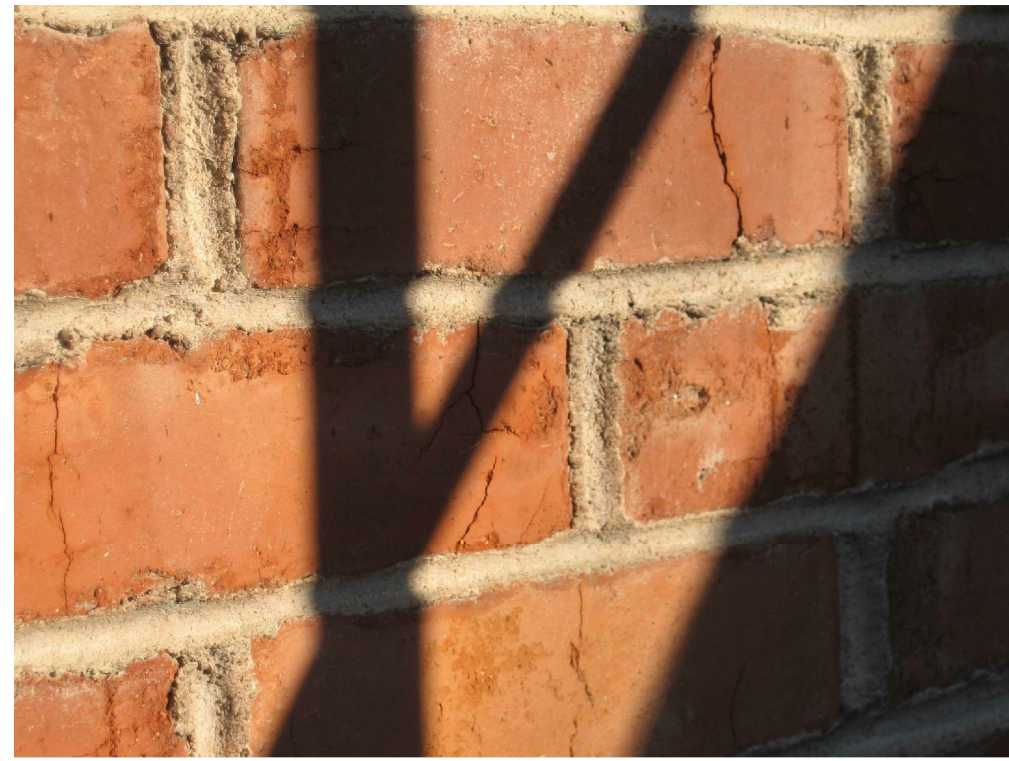
3 CRACKED BRICK

- A. PULL LOOSE GROUT AROUND SANDSTONE WINDOW SILLS AND REPOINT. REPOINT ENTIRE LENGTH OF SILL, SIDES AND BOTTOM.
- B. REPAIR DEEP CRACKS IN BRICK. ASSUME 25% OF BRICK HAS DEEP CRACK.

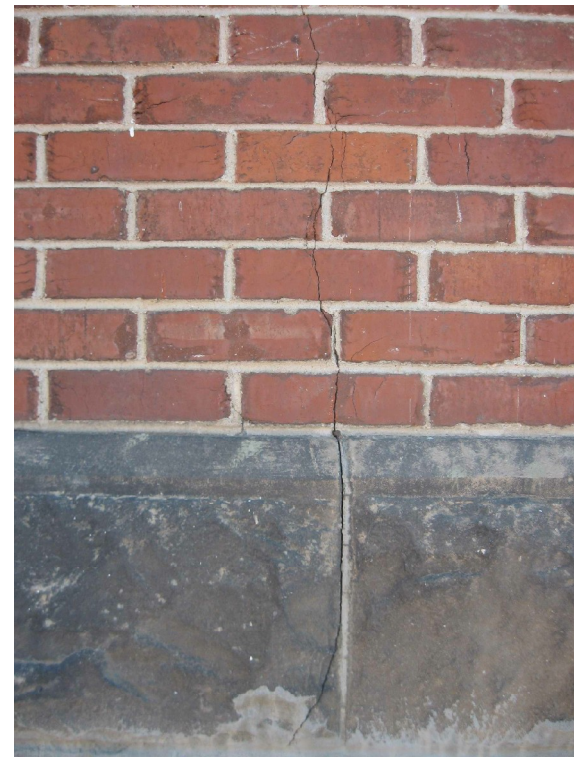
4 CRACKED BRICK, MORTAR JOINT, AND SANDSTONE

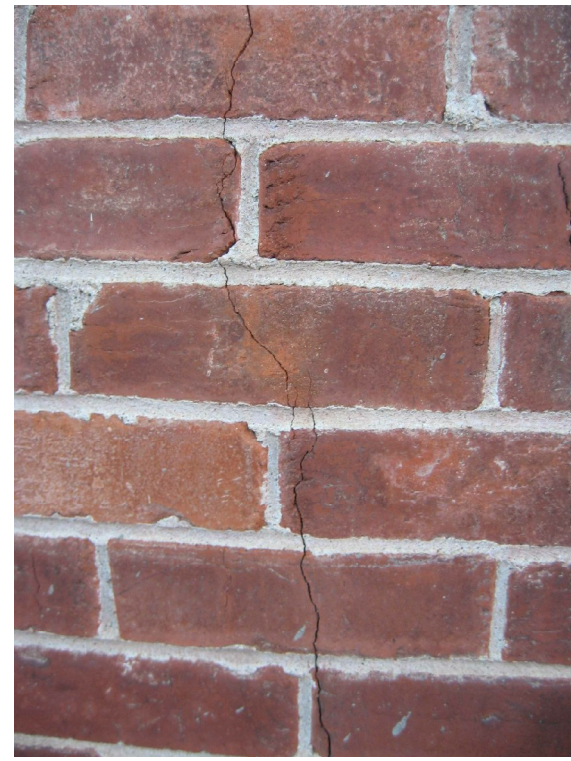
5 CRACKED BRICK AND MORTAR JOINT

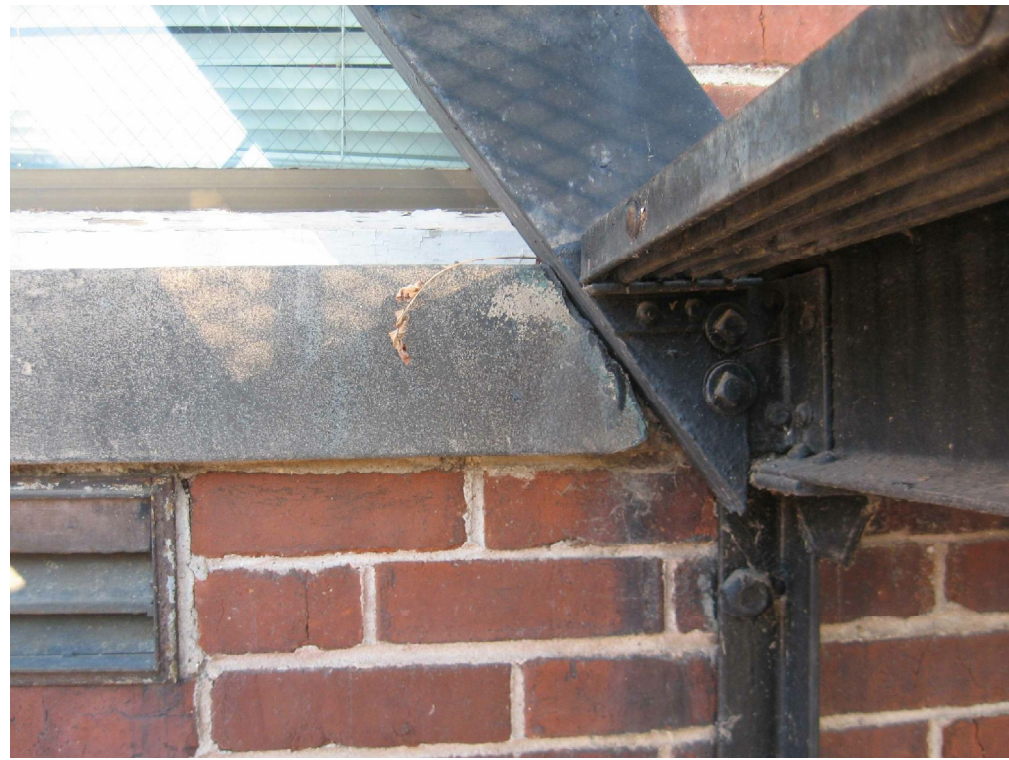
6 DAMAGED / MISSING SECTION OF SANDSTONE

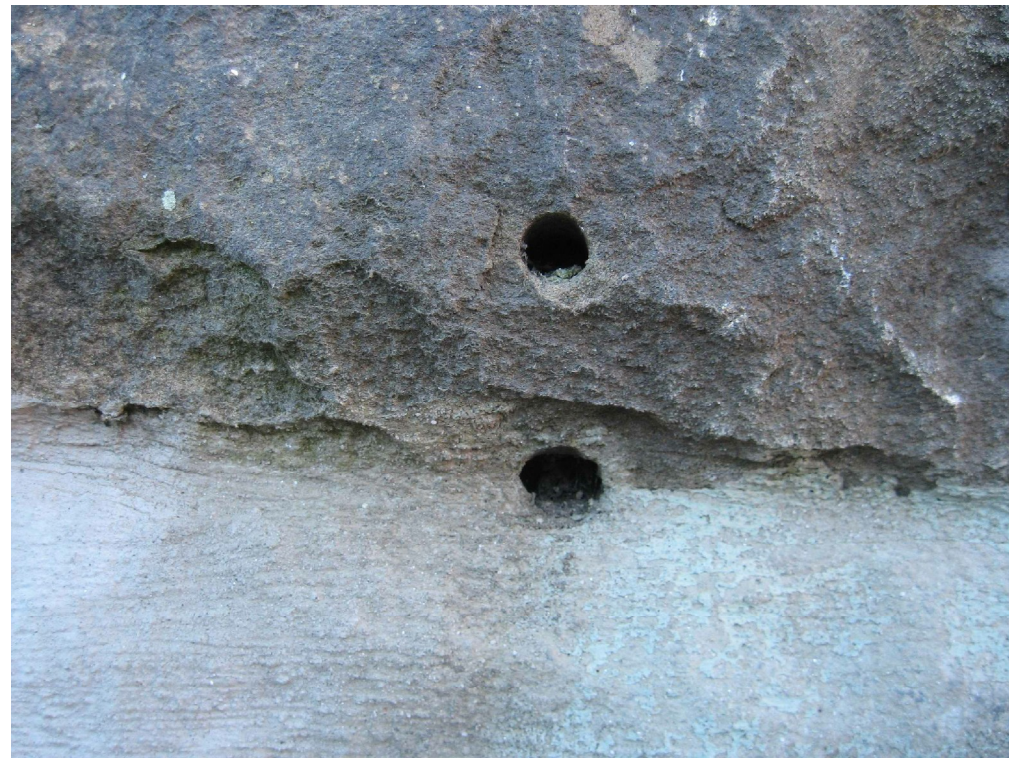
7 HOLES IN SANDSTONE

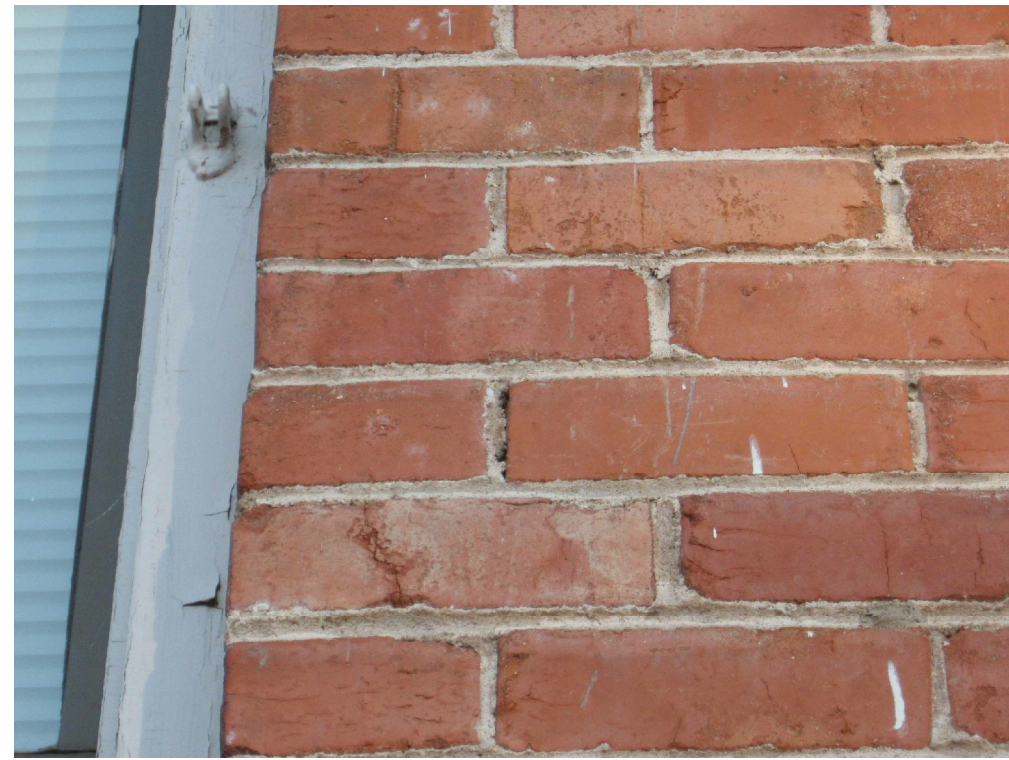
8 LOOSE GROUT IN BRICK

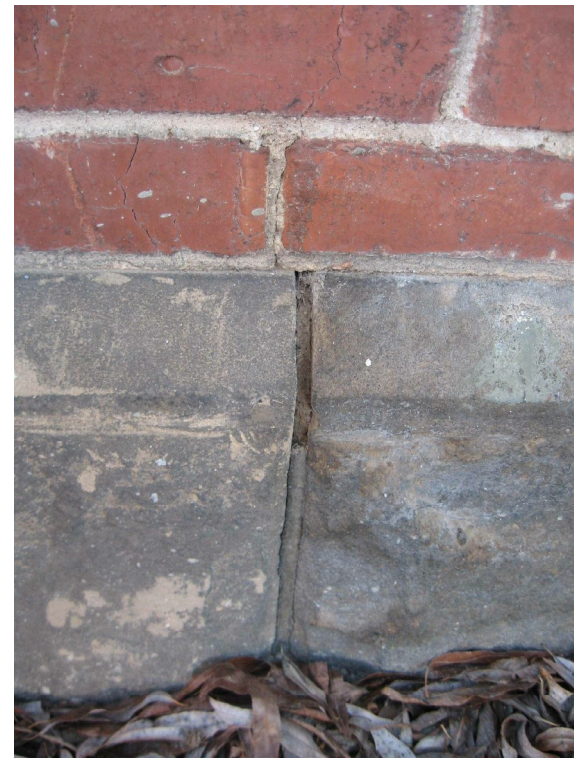
9 MISSING GROUT IN SANDSTONE

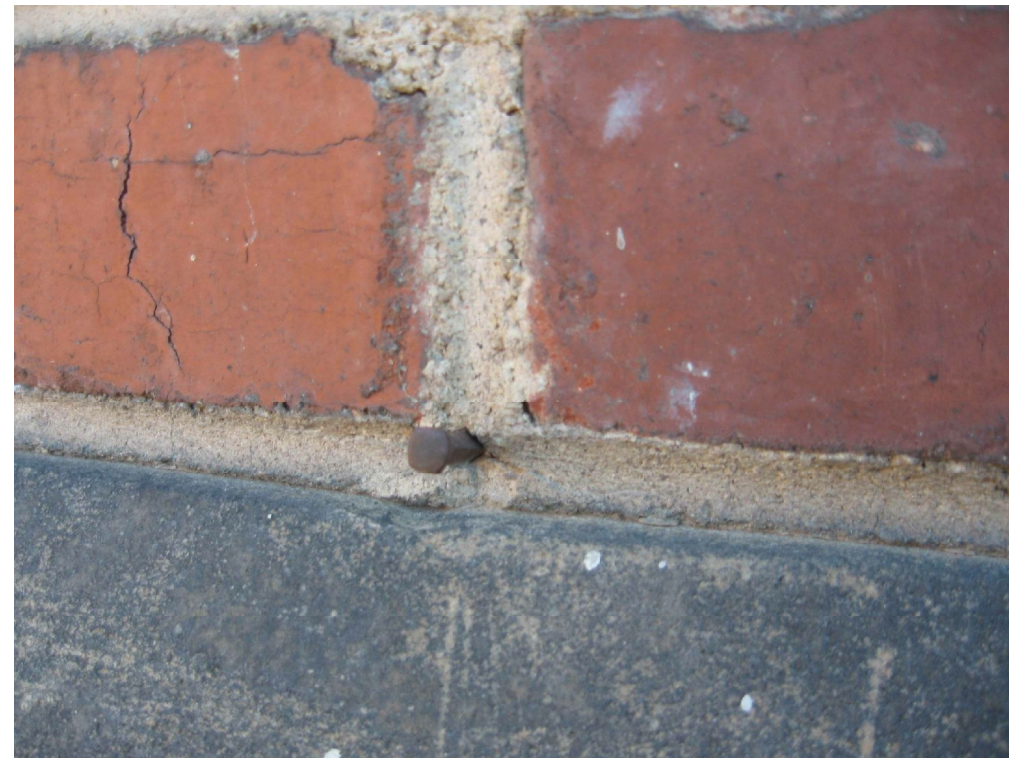
10 NAIL

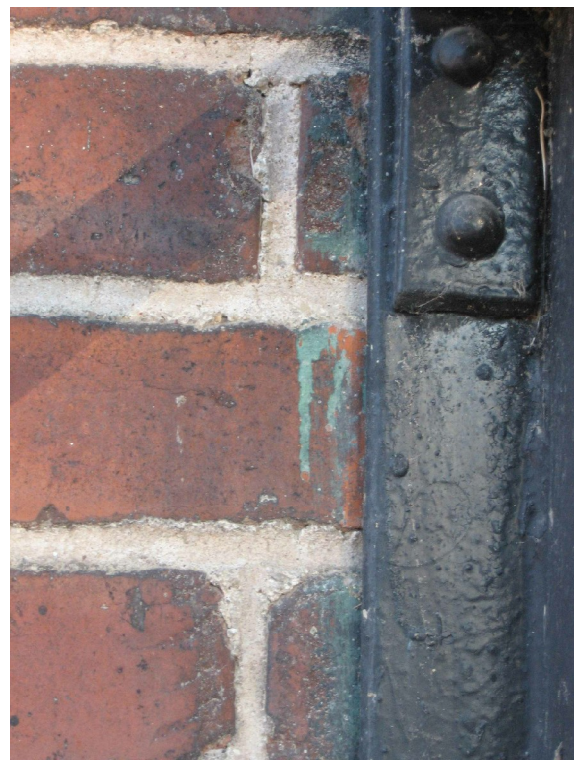
11 PAINT ON BRICK

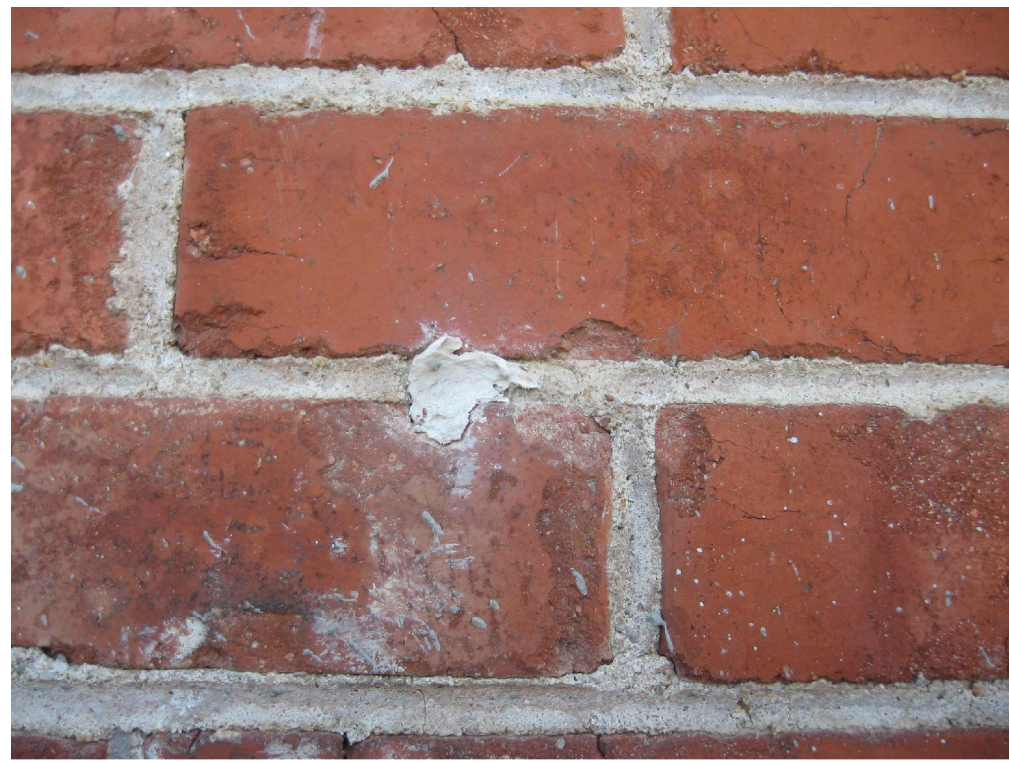
12 OLD PATCH IN MORTAR JOINT AND BRICK

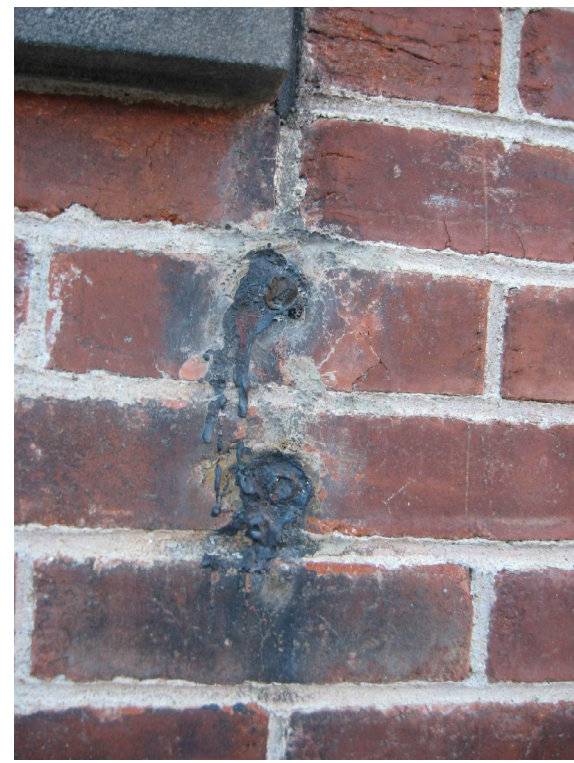
13 OLD PATCH IN BRICK

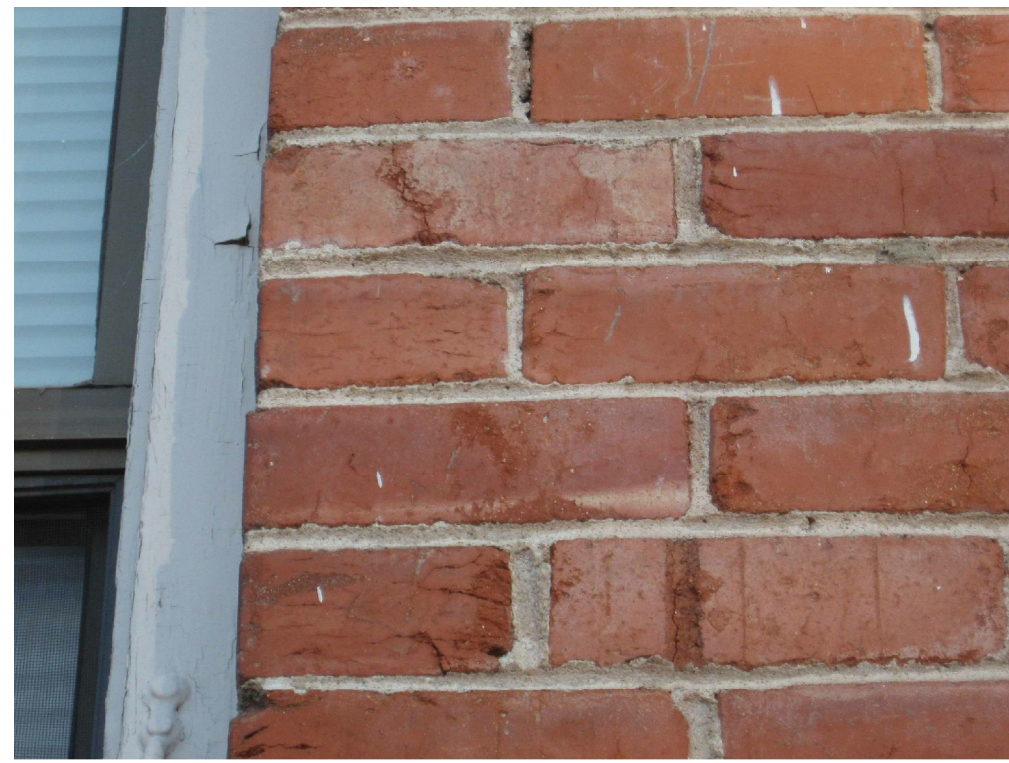
14 SPALLING BRICK

- J. BRICK SPALLING MAY BE CAUSED BY A VARIETY OF ISSUES INCLUDING, INCOMPLETELY FILLED JOINTS, PLANT GROWTH, CAPILLARY RISE, DIFFERENTIAL MOVEMENT, PREVIOUSLY APPLIED SEALANTS, AND FREEZE/THAW CYCLES, ETC. IF THE SPALLED BRICK DOESN'T PROVIDE AN ADEQUATE EXTERIOR WEATHER VENEER, THEN IT SHALL BE REMOVED IN FULL FROM JOINT TO JOINT AND REPLACED W/ NEW OR SALVAGED

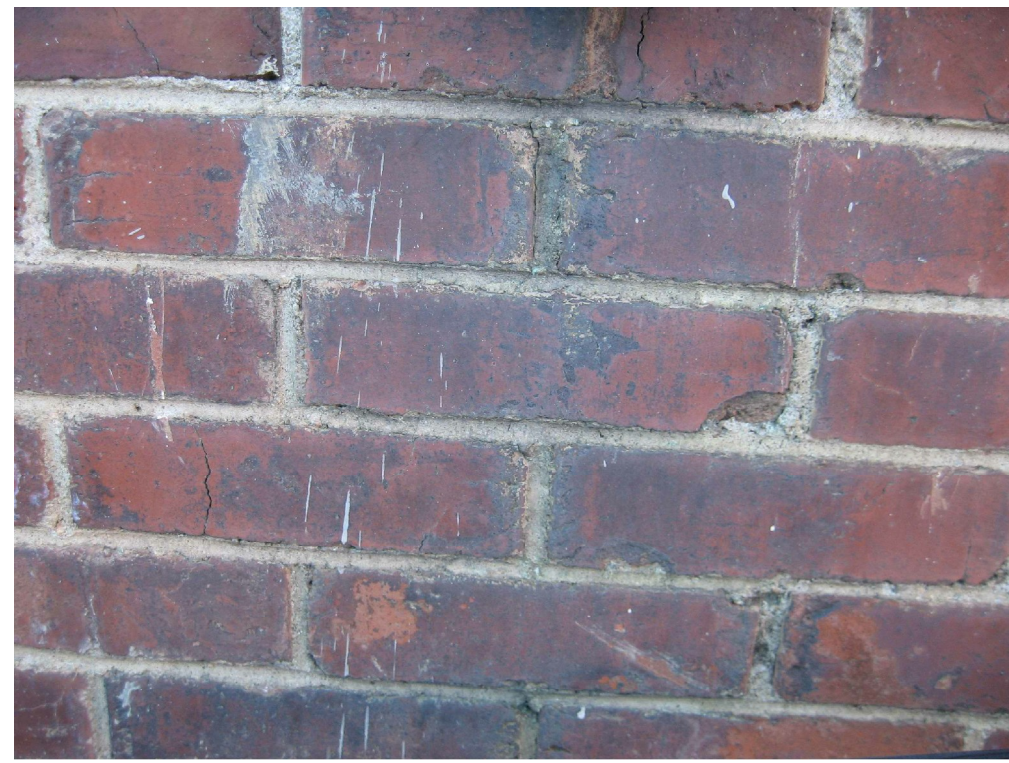
15 STAINED BRICK
